# ES\_QN908x

Errata sheet QN908x

Rev. 1.1 — 23 February 2018

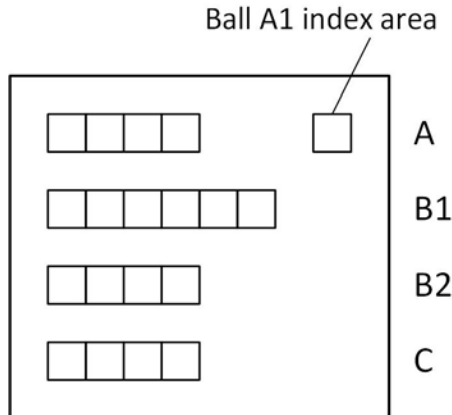
Figure 2 WLCSP47 package marking

The QN9083 WLCSP package has the following top-side marking:

- Line A: “9083” for QN9083
- Line B1: xxxxxx

- Line B2: xxWW
  - WW: week code.
- Line C: YY[R]x
  - YY: year code, 16 for 2016.
  - R = Chip revision.
